Support Services for the Automotive Gas Turbine Project

Summary Report

Edited by
T. Golec
Chrysler Corporation
Detroit, Michigan 48288

April, 1981

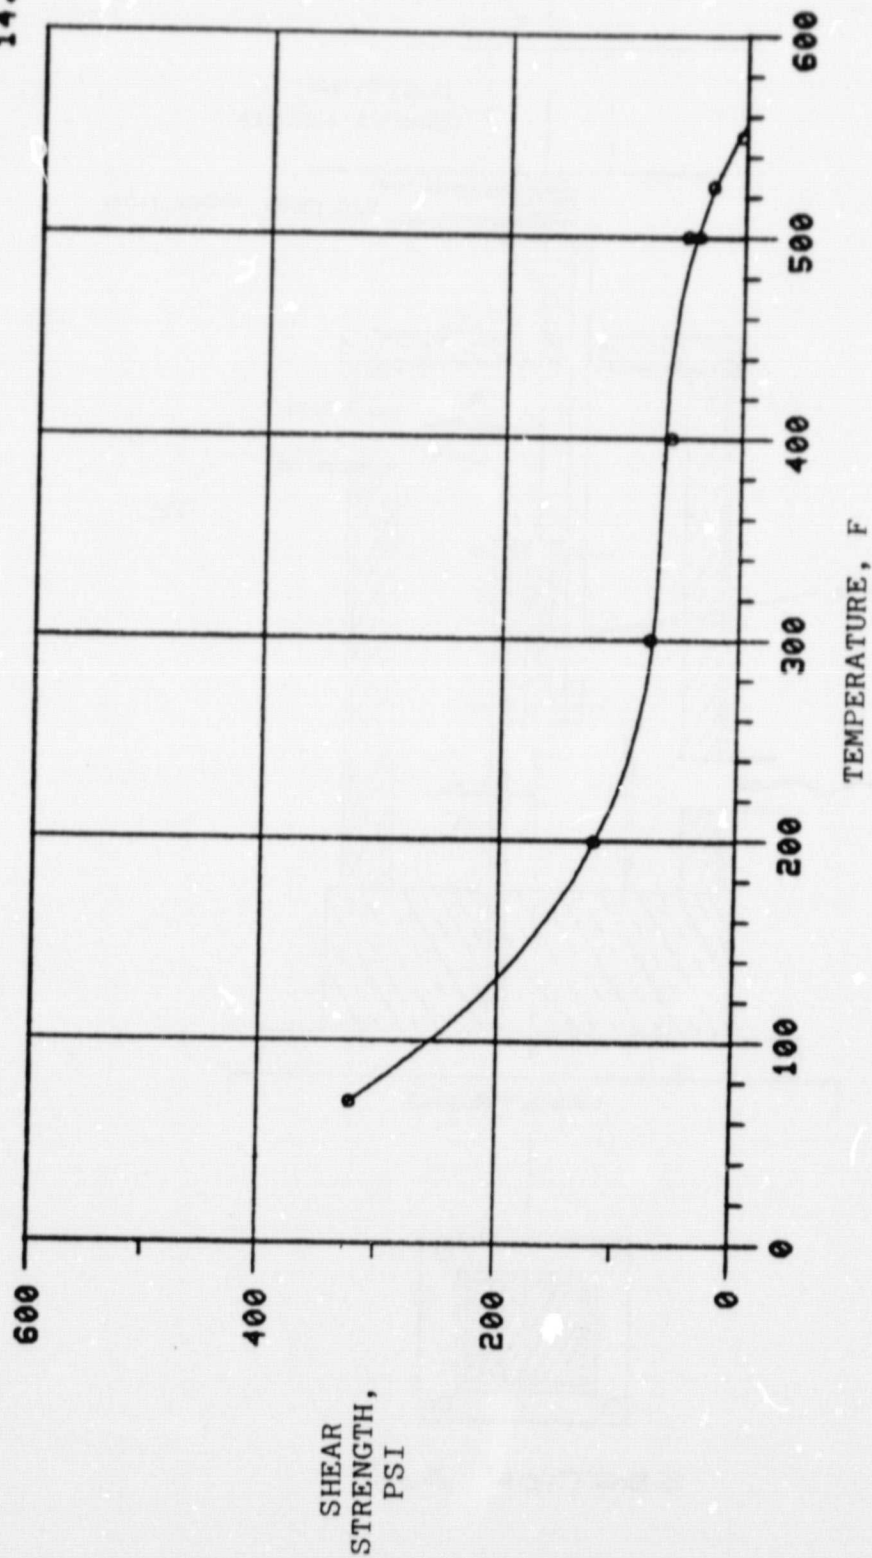
FIGURE 27

The fixture was then modified to allow shear testing at elevated temperatures, as shown in Figure 26. Preliminary test results, shown on Figure 27, indicate a substantial drop in material properties in the 300-500°F range, but the design safety factor is still 14 at 500°F. It was noted that specimens tested at 500°F and above failed in the shear mode (as compared to the peel mode for the room temperature samples), which matches the failure mode observed at NASA. Samples between 300 and 500°F showed evidence of both failure modes. Testing of Sylgard 186 and candidate replacement materials is continuing with emphasis on the critical 400-600°F range.

ELASTOMER TEST RESULTS, ELEVATED TEMPERATURES

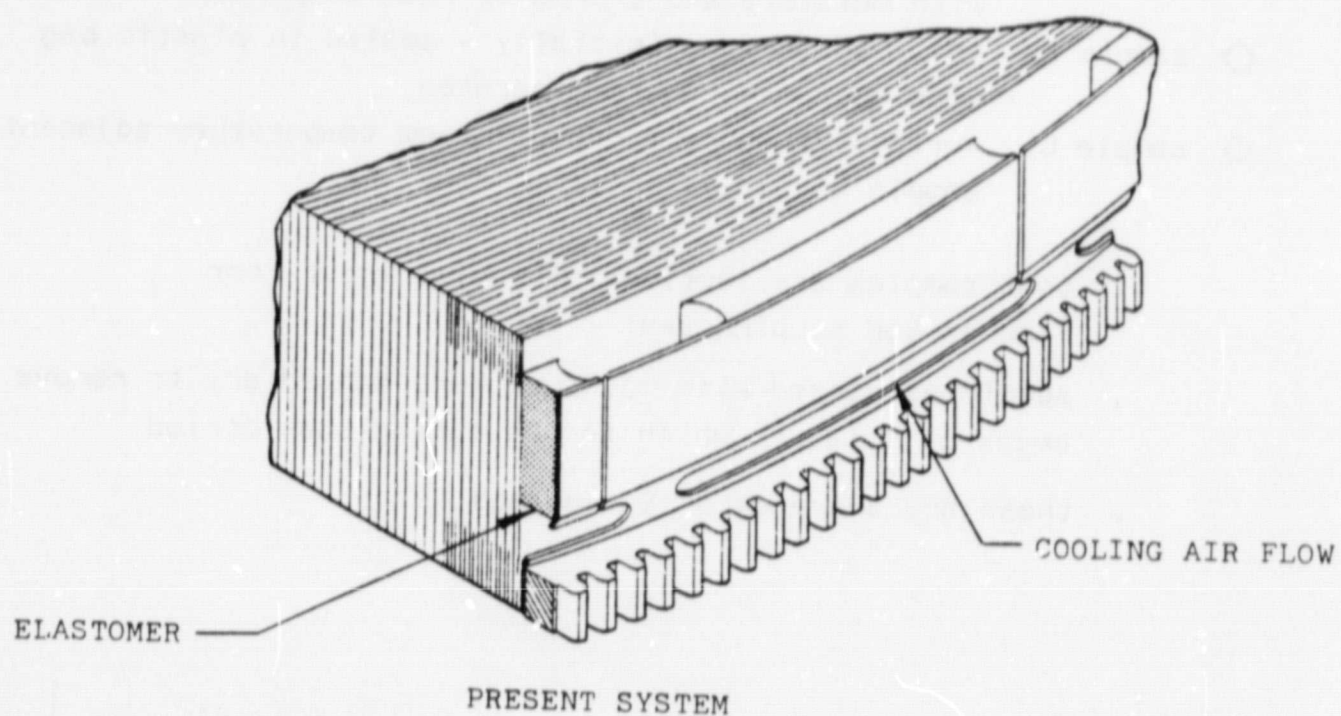
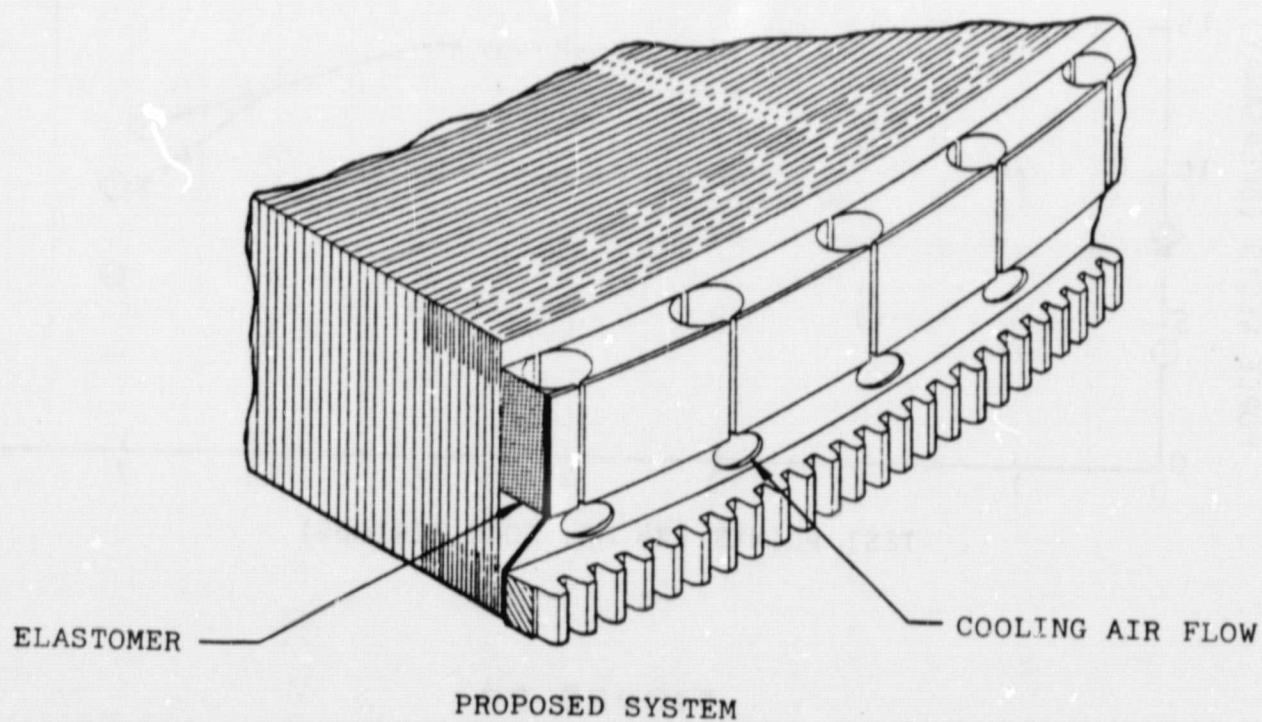
FIGURE 28

Should it be determined that reduced shear load on the A926 regenerator drive elastomer is needed, a design with increased elastomer shear area has been proposed. This design, shown schematically in Figure 28, is an adaptation of the AGT configuration. It permits an increase in elastomer shear area by at least 75%, reducing maximum shear load to approximately 2 psi. Other advantages include:

A-926 CERAMIC REGENERATOR
PRESENT AND PROPOSED ELASTOMERIC MOUNTING SYSTEMS

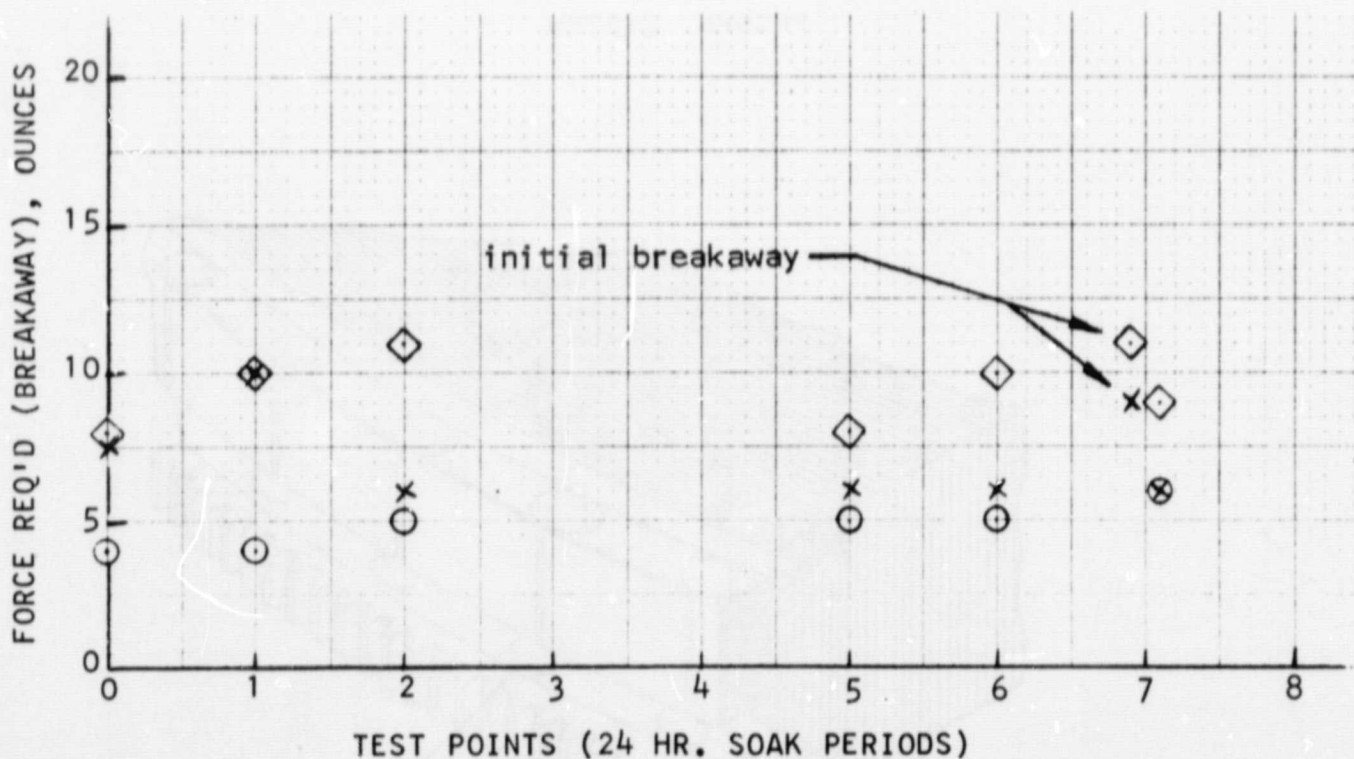
FIGURE 29

As discussed on page 3 of Failure Report 81 in Appendix C, graphite seals are subject to contamination with atmospheric moisture, resulting in momentarily higher friction loads until the heat of friction and/or combustion can evaporate it. Preliminary tests, using small samples of graphite statically loaded on a representative matrix surface, showed that breakaway torque can double in the presence of moisture (see Figure 29). However, for this condition to seriously affect elastomer life, a condition of maximum load and zero regenerator speed would have to be achieved (equivalent to 100% gas generator speed and a stalled power turbine) - an impossible situation. No additional investigation in this area is planned, although the seal friction and wear test machines now in operation could be used for further evaluation of graphite seal dynamic friction vs. moisture content should the need arise.

BREAKAWAY FORCE VERSUS TIME

HUMIDITY EFFECT ON GRAPHITE

- x sample A polished surface initially - sealed in plastic bag with moisture and stored at room temperature
- ◇ sample B polished surface initially - sealed in plastic bag with moisture and refrigerated
- sample C surface as-run - stored at room temperature adjacent sample A

- . test samples are sections of failed inner rear regenerator rubbing seal
- . specimens stored with moisture were dabbed dry to remove beads of moisture which formed during soak period
- . these are averages of 5 readings

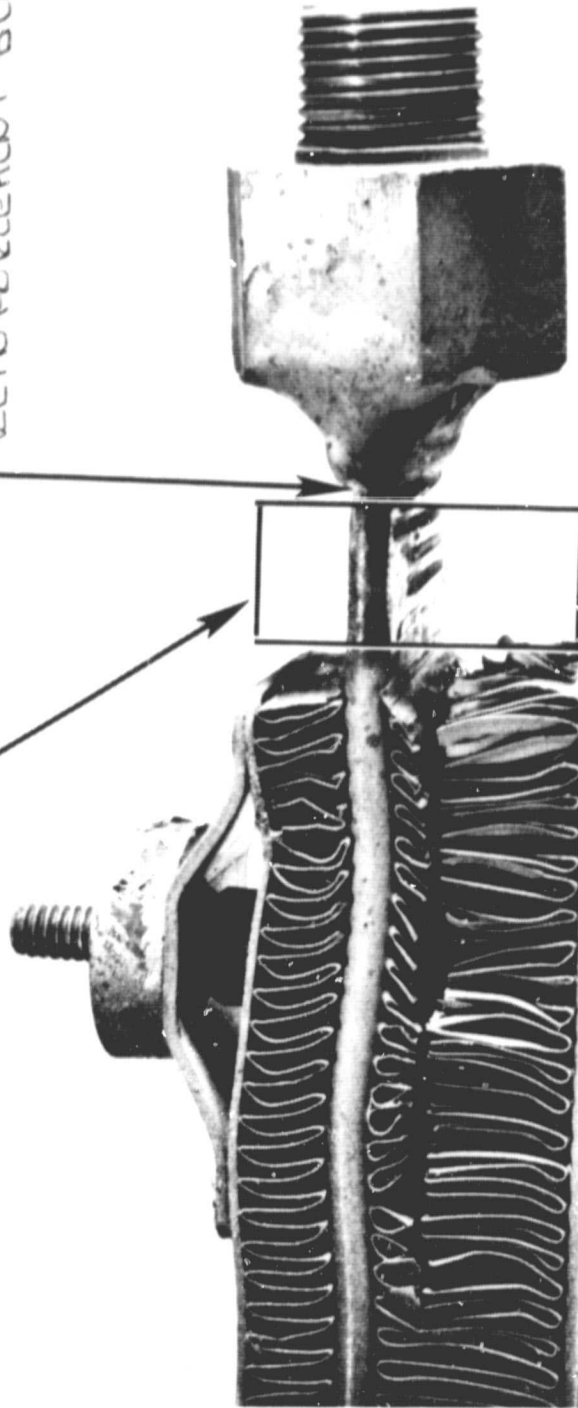
A REINFORCEMENT BLOCK
NORMALLY OCCUPIES THIS
AREA.

TUBE CRACKS ON UPPER
SURFACE (NOT VISIBLE IN
THIS VIEW) AND ADJACENT
REINFORCEMENT BLOCK

CAR 645 PP 8-10L
307.0 MILES DRAWN
16,200 MILES SWIPPED (EST.)
A/C CONDENSER

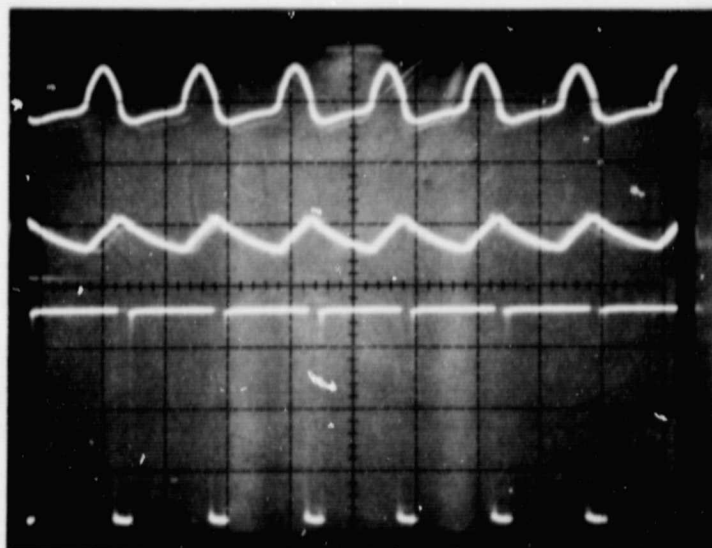
The left pick-up had an installed gap of .021" while the right pick-up had an air gap of .012". Photos 5 and 6 represent engine operation at 90% Ngg with the left pick-up. Loss of governed speed control occurred at approximately this speed with ECU #111 and Bd. 6 S/N 111. Previous engine operation lost speed control with ECU #113 and Bd. 6 S/N 113 at 80% and at 85% with this ECU and Bd. 6 S/N 111. Note the improved signal at pin 4 of ICI and duty cycle change of TPI with R13 lowered to 1000 ohm as shown in photo 6. Photos 1 and 2 show engine operation at 75% Ngg. Photo 1 with the original value of R13 and photo 2 with R13

R13 = 4700 ohms

75% Ngg

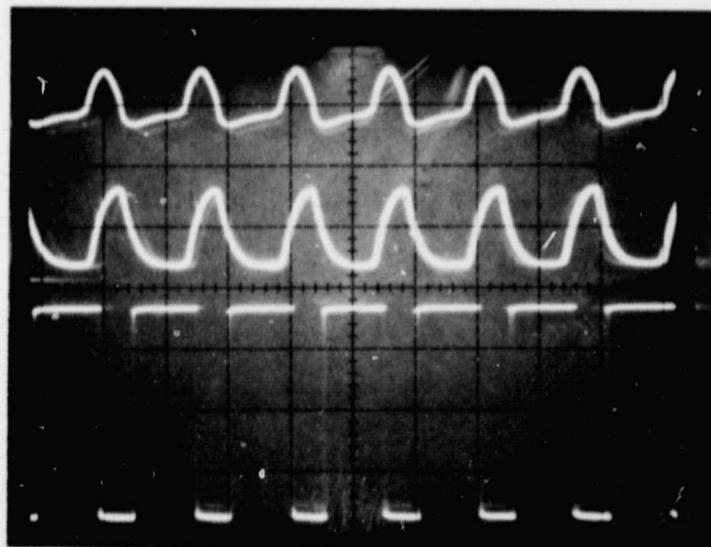
Photo 2

R13 = 1000 ohms

75% Ngg

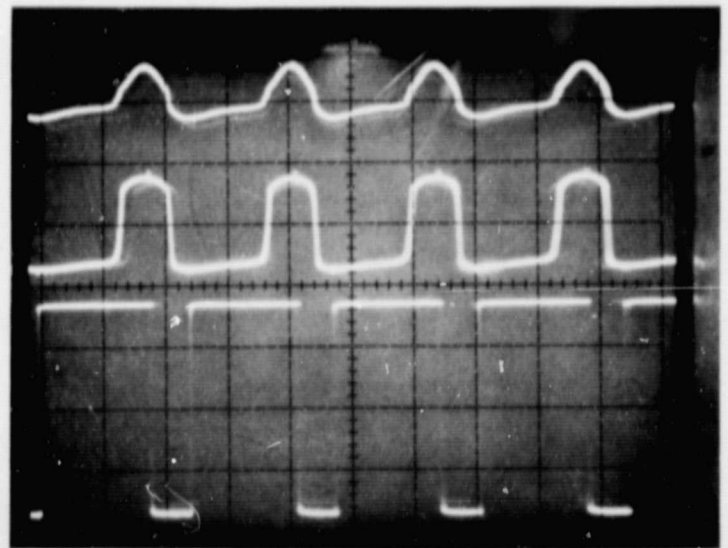
Engine operation at 50% Ngg is shown in photos 3 and 7 with the lowered value of R13. In Photo 3 the right pick-up is utilized and channel 2 shows the diode clamp waveform. In Photo 7 the left pick-up is utilized.

R13 = 1000 ohms

50% Ngg

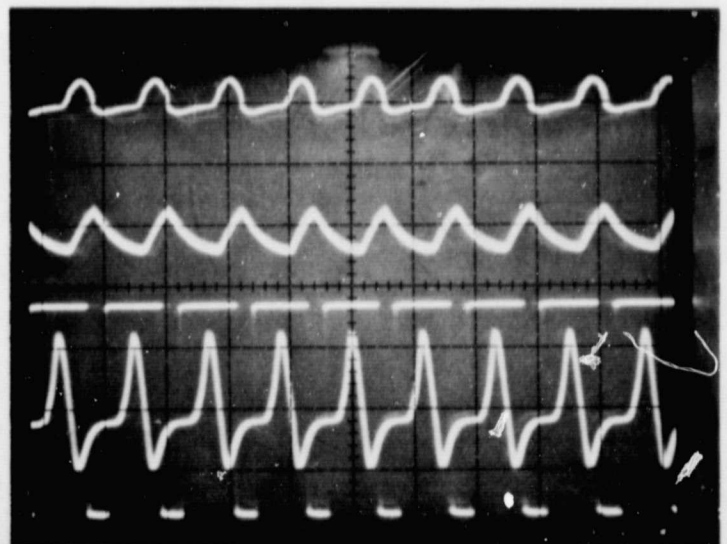
Photo 4

The attached figures show eight oscilloscope photos with the applicable calibrations and conditions. Photos 4 and 8 represent the two speed pick-ups and processing signals at pin 4 of ICI and TPI of board 6 at 50% Ngg. The circuit loading of the pick-ups is clearly represented by voltage reduction and waveform alteration.

Ch. 4, 5v/div
Ngg pickup (R/H)

R13 = 4700 ohms

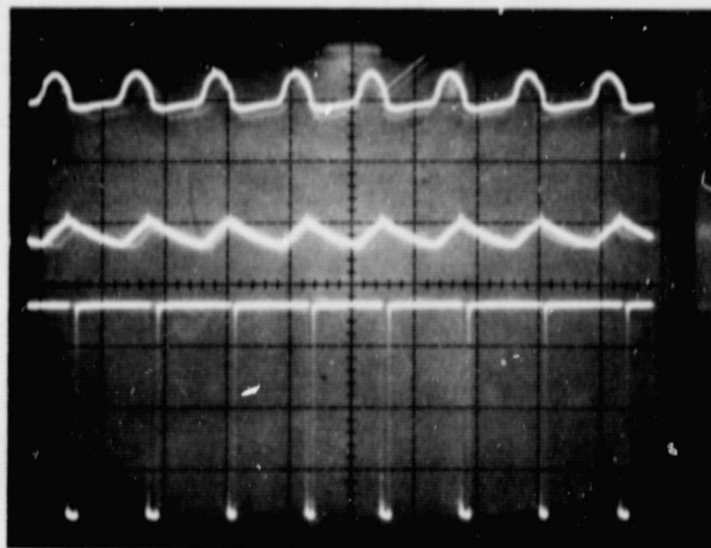
Photo 5

R13 = 4700 ohms

90% Ngg

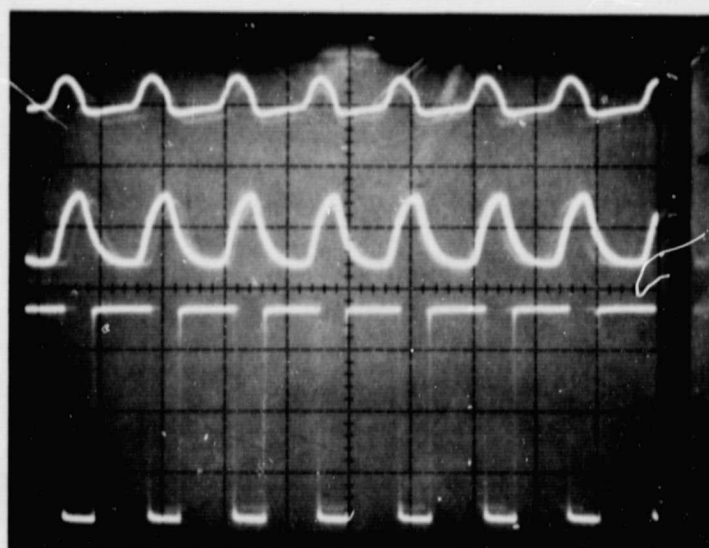
Photo 6

R13 = 1000 ohms

90% Ngg

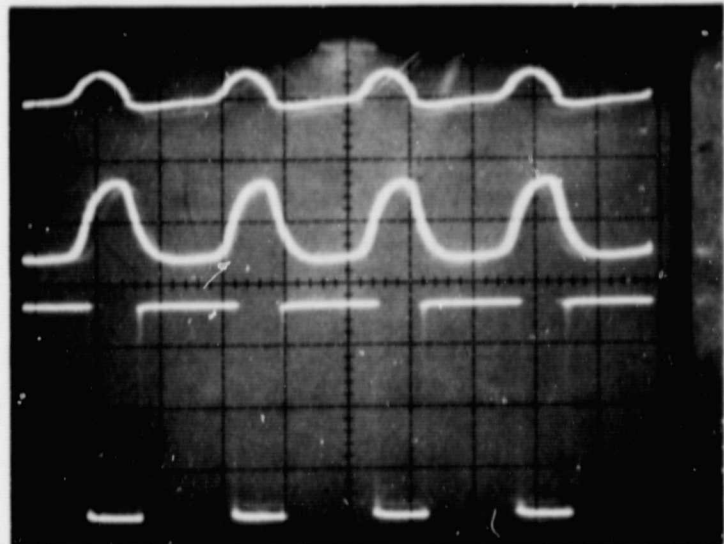
Photo 7

R13 = 1000 ohms

50% Ngg

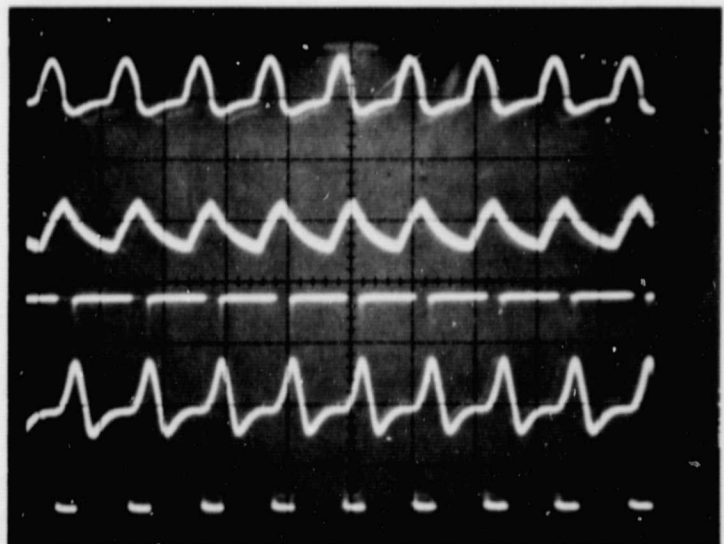
Photo 8

Ch. 4, 5v/div
Ngg pickup (L/H)

R13 = 4700 ohms

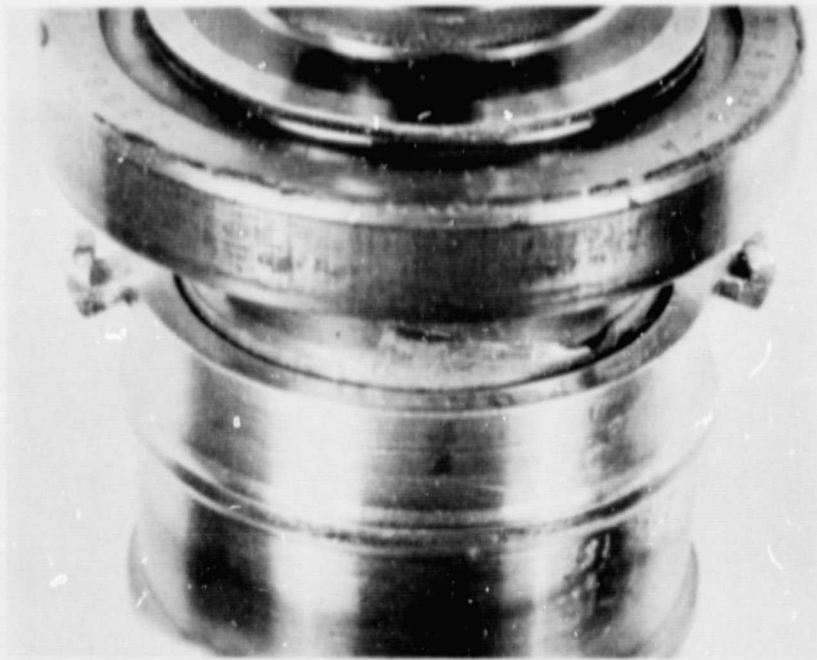
Figure 1. Front

Gas generator seized at 153 hrs. Prior to failure the smooth and corrugated foils had moved partially out of the cartridge. Due to the extent of the damage caused by the seizure the cartridge had to be slit to separate it from the journal. (Figs 1 through 3). Examination at low magnification revealed a short length of the foil attachment and bump block had escaped destruction (Figs 3 & 4). The fractured end of the smooth foil protruding from the rear of the bearing and the remaining weld nuggets and fractured smooth foil on the bump block, at the front of the cartridge, suggest that the primary failure occurred by fracture of the smooth foil at the spot weld line. That section of the cartridge was cut out for fractography. A small portion of the primary fracture face was found intact except for heavy edge deformation where rubbing by the journal had occurred. SEM fractographic analysis (Figs 5 & 6) of the small undamaged area showed the fracture mode was largely cleavage. Although no clear evidence of striations could be found, it is probable that fatigue was the primary cause of fracture of the smooth foil at the spot weld line.

AIR BEARING (S/N 6-2)

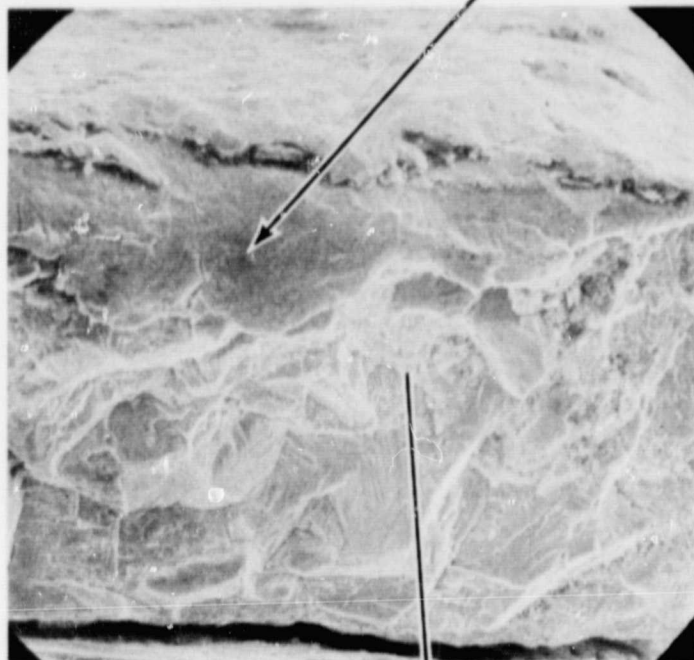
Figure 5.

(800X)

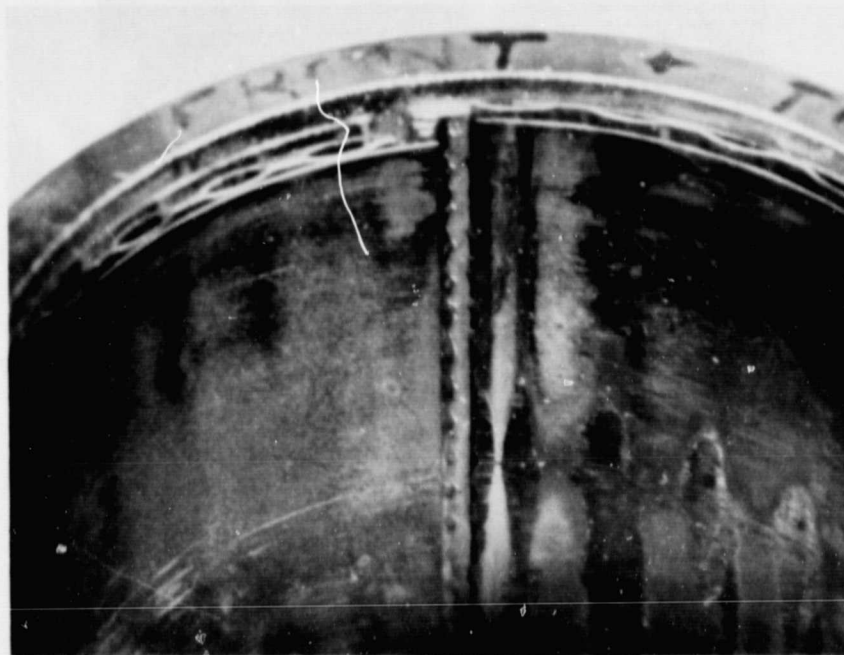
Figure 1
Front of Bearing

Fracture of the smooth foil was found to extend the full width of the foil at the spot weld line. (Figs 1 & 2). Scanning electron microscope fractographic analysis revealed evidence of fatigue failure originating between weld nuggets at the rear of the bearing. The fracture appears to have followed the contours of most weld nuggets in propagating across the foil, leaving them intact and attached to the bump block. (Figs 3 through 8) Contact damage or deformation at the fracture occurred after foil failure.
